Water Resources Department

November 23rd, 2016

Re: Ferry Creek Dam (F-25) – Inspection Summary

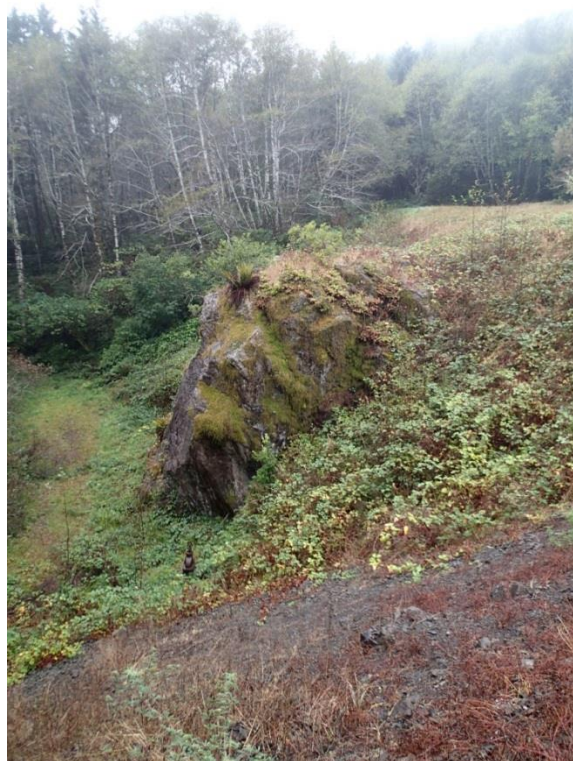
Vegetation on the downstream slope, right abutment and toe of the dam

There is also a significant amount of vegetation on the downstream face, left and right abutments, and toe of the dam. Extensive vegetation prevents complete inspection of the dam surface and outlet control works. Visual inspection makes it possible to identify any deficiencies that may lead to unsafe operation of the dam; it is a critical component of a dam safety inspection. Common issues identified through visual inspection are embankment stability and movement, seepage, animal activity, poor condition of penetrating conduits, and lack of functionality of the outlet works.

4. Remove debris and vegetation from the spillway channel so that the channel remains unobstructed and functions as designed.
5. Remove vegetation from the downstream face of the dam, right and left abutments, and toe of the dam.

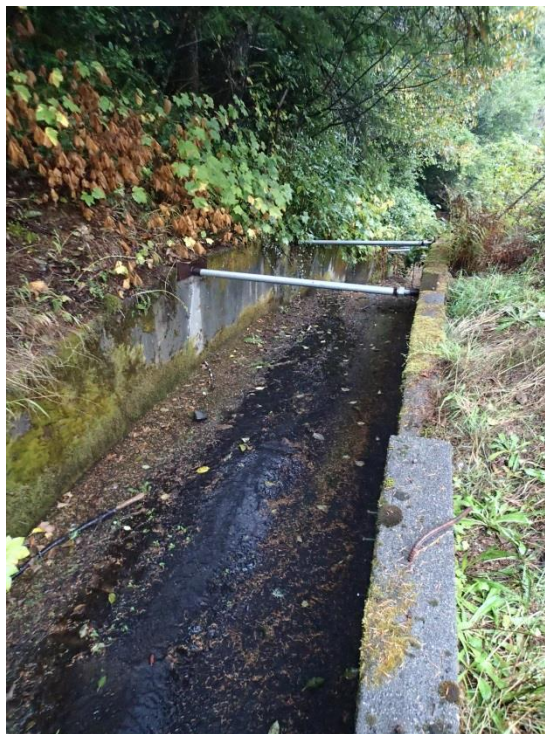
Steel struts preventing spillway channel retaining wall failure

Based on measurements taken during our inspection, the spillway appears to be undersized for a moderately sized storm event. It should be noted that the only definitive means to determine if the spillway is truly undersized, is through a detailed engineering analysis. However, our rough calculations indicate that there is enough reason for concern regarding the spillway capacity without the need for a full engineering analysis at this time. Consequently, it is extremely likely that in a moderately sized storm event the dam will be overtopped, possibly leading to a catastrophic failure of the dam.

In addition, the retaining walls of the discharge channel for the spillway are beginning to fail. The walls are currently held in place by steel struts. These struts are located within the spillway channel and therefore present an obstruction to flow. As a result, the capacity of the spillway is reduced from the “as-designed” condition.

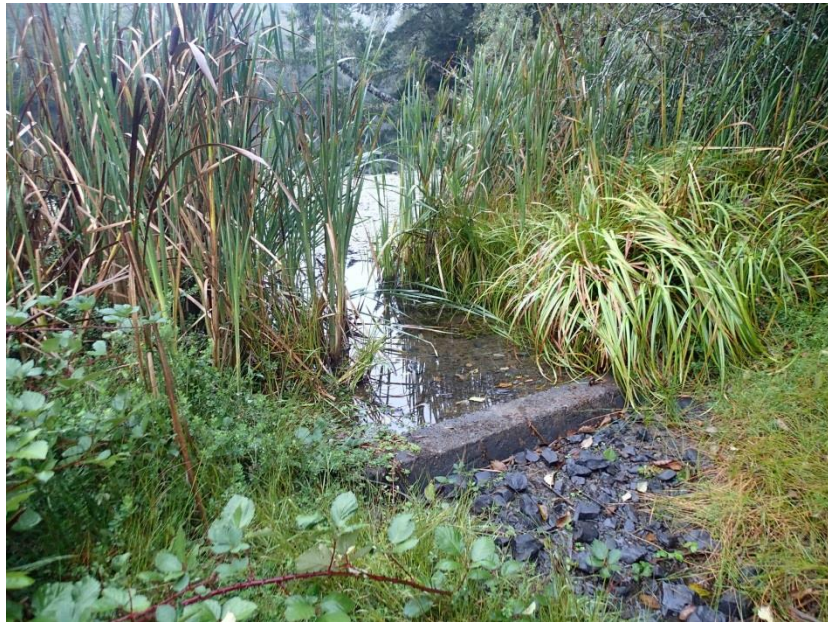
Vegetation in the emergency spillway control section

There is a significant amount of vegetation in the emergency spillway control section and channel. It also appears that there was land slide into the spillway at some point in the past. This is evidenced by the fact that the control section (shown in the image above) is partially buried and the section, in its current condition, is not uniform. It also appears that there is a significant amount of material in the discharge channel just downstream of the control section. Both the vegetation and the material from the slide obstruct flow through the spillway and therefore reduce the capacity of the spillway to pass flood flows.

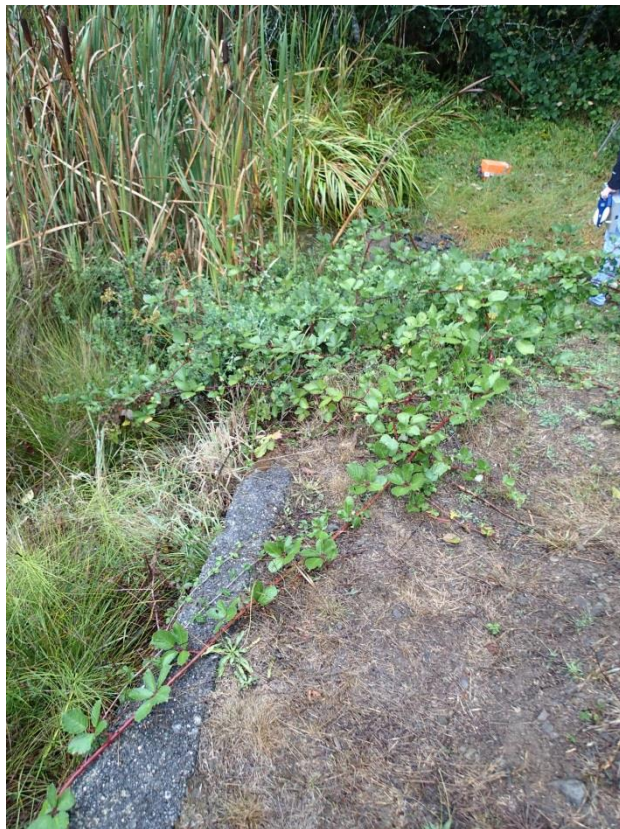
Partially buried spillway control section

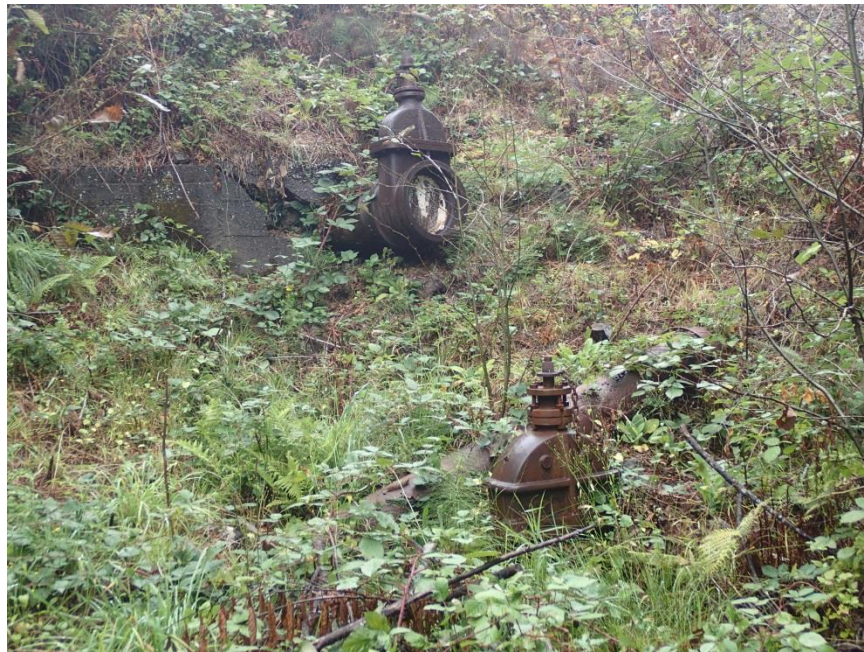
Intermediate conduits with valves

There are multiple conduits that penetrate through this dam. This is very atypical. Each conduit provides a potential location for leakage into the dam. Two of the conduits have valves on the downstream side which suggests that they might be pressurized. However, the upper intermediate conduit (upper left in the photo above) has a cracked housing so it is likely not pressurized. A conduit is pressurized when the control valve is at or below the outlet of the dam, instead of in the reservoir on the upstream face. Most dams are designed for gravity flow, not for pressurized conduits. Conduits are pipe, and depending on the type of pipe and the age of the pipe, risk of high-pressure leakage exists in a pressurized system. In an earthen dam, this high pressure water can cause severe internal erosion, and this can result in rapid dam failure. It does not appear that either of the two intermediate conduits has been used in some time.

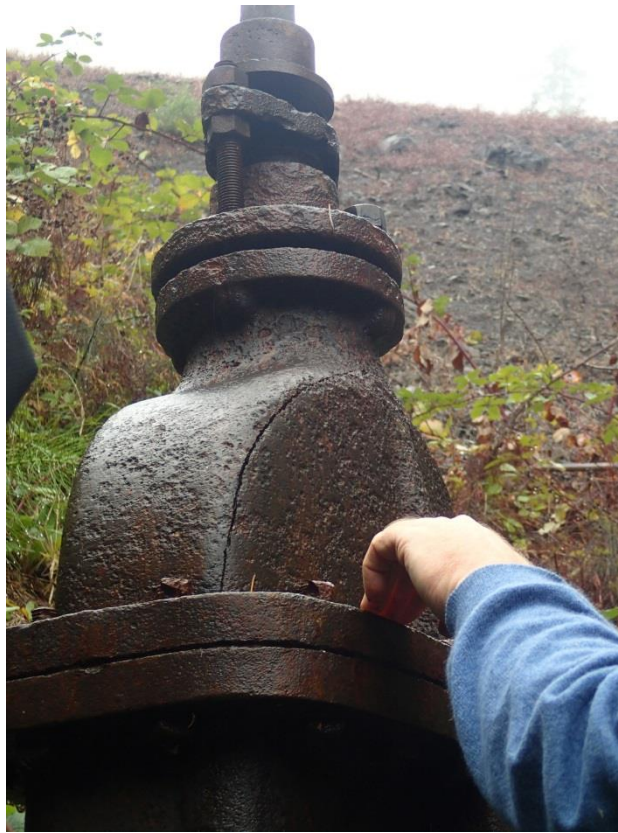
Crack in housing of upper most intermediate valve

Comments:	• UPPER PIPE 16" CONCRETE PIPE W/ 16" CRANE GATE VALVE. HOUSING IS CRACKED SO IT IS NOT LIKELY IT IS PRESSURIZED • MORE VALVES? • LOWER VALVE 30" CS, 15-20 CFS LEAK

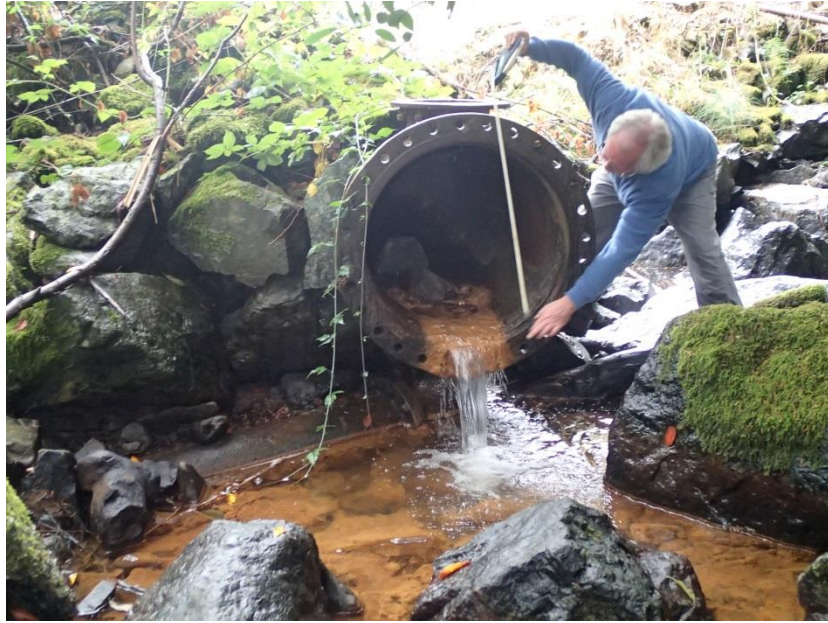
Low level conduit

There is also a low level conduit that is not pressurized. This pipe is clearly leaking at approximately 15 to 20 cubic feet per second. Either the gate valve on the upstream side is partially open or there is a leak in the upstream valve or somewhere along the conduit. We were unable to inspect the upstream gate valve because it was submerged. There are no visible controls for the low level conduit. As a result, it is not operable. A properly working outlet conduit is a key safety feature of a dam. The controls and conduit must be functional to drain the dam during an emergency.
